SHELL LEMAN DELTA REPORT DOCUMENTS

Leman Delta - Enviropeel Inspection Visit – 10.08.16

SHELL LEMAN DELTA FOLLOW UP REPORT

SHELL LEMAN DELTA

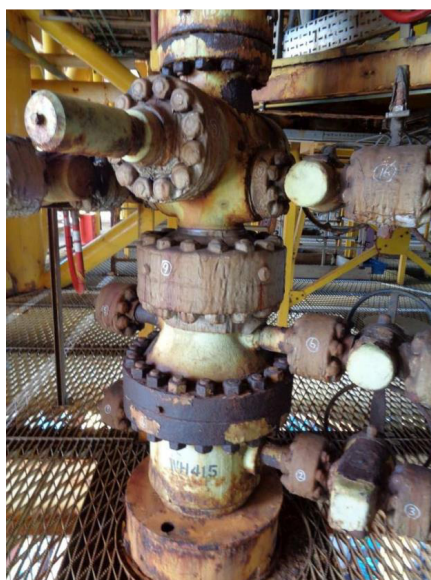
The writer arrived on the Leman Delta Platform and following the relevant introductions, inductions and permits being raised entered the Well Head area with the Bilfinger operative. An initial inspection of the Enviropeel applied to the branch flanges of WH415 indicated no obvious signs / areas of premature material breakdown or failure had occurred. The material had obviously discoloured and weathered as would be expected when exposed to the required service environment. See picture

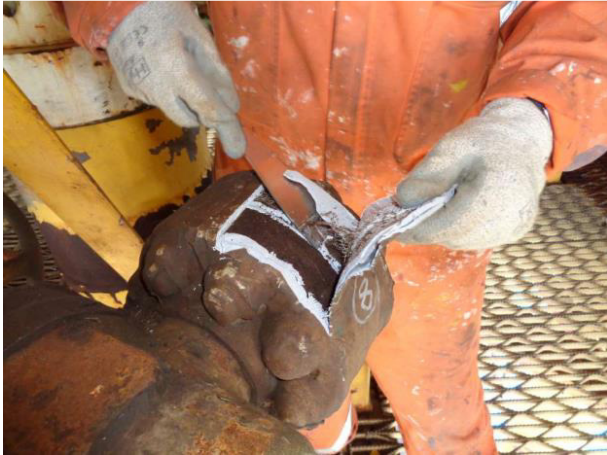
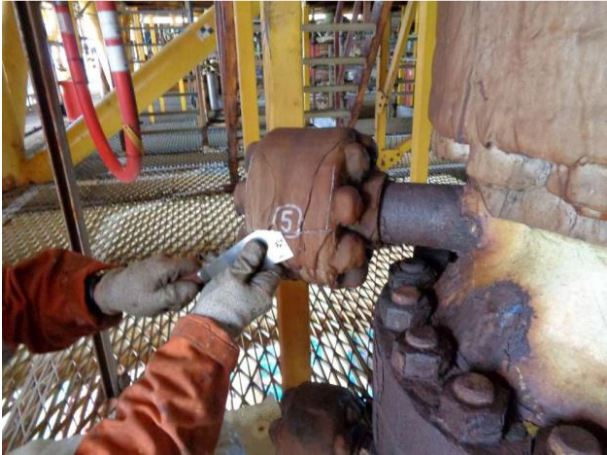
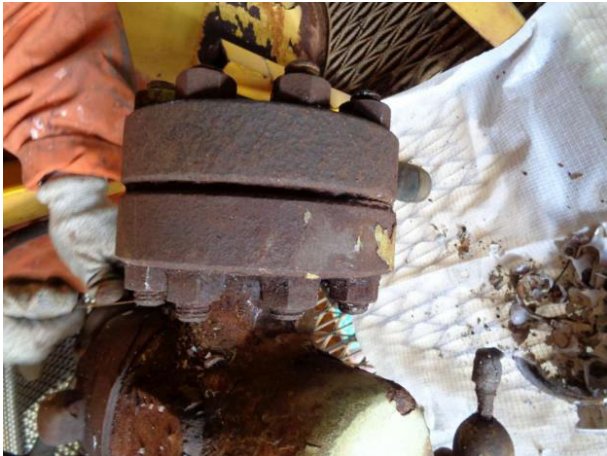
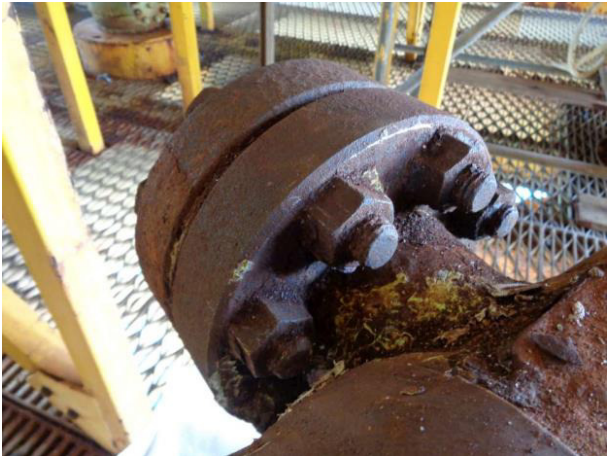
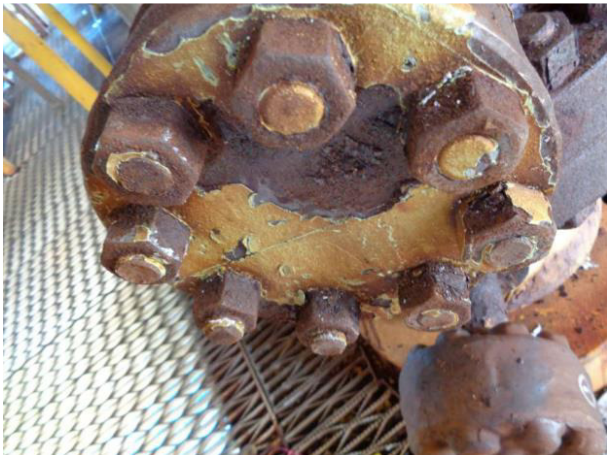
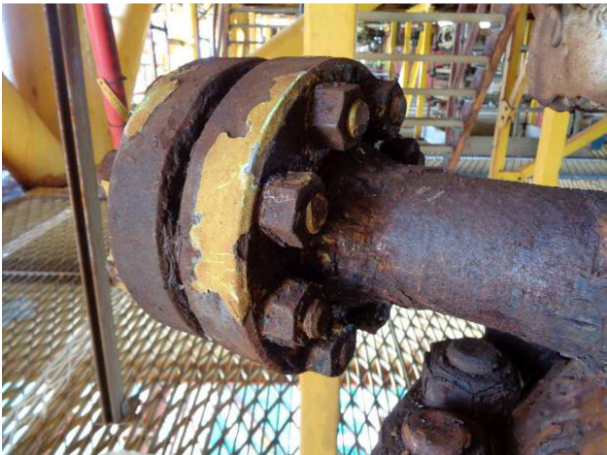
It was decided that Enviropeel applied to Flanges No5 & No8 would be removed for assessment purposes. Flange No5 was removed first. A standard scraper was used to make the initial incision, once penetrated the Enviropeel was easily removed and for want of a better expression 'peeled of like wallpaper'

Once the Enviropeel had been fully removed a visual inspection of the exposed substrate was carried out. When compared to the flanges that were prepared prior to the Enviropeel application in 2010 and pictured in 2010 A&E Systems report titled '*Shell Leman Delta – Follow Up Report*' the writer would confirm that little or no further substrate degradation or corrosion build up has occurred on either Flange No5 & No8.

On Flange No5 there was an amount of residual coating still in place. The writer assumes that this coating must have been tightly adhered to the substrate when the initial Enviropeel application took place in 2010. Upon examination and using a blunt scraper to indicatively test the current adhesion the writer would state that this residual coating, after 6 years encapsulation using Enviropeel, remained tightly adhered to the substrate, indicating no moisture ingress or corrosion creep.

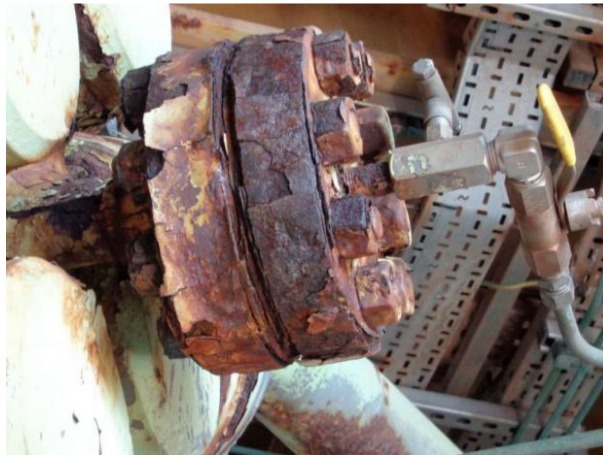
In comparison a flange on WH415 that was not encapsulated using Enviropeel and had remained exposed for the previous 6 years exhibited excessive corrosion and scale build up. See picture

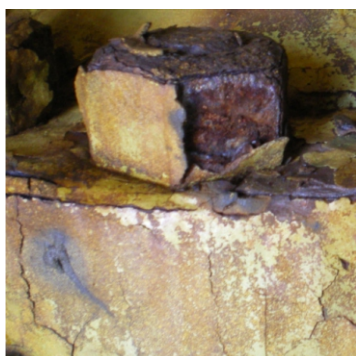
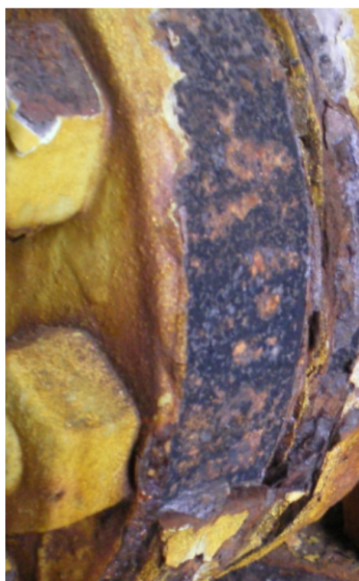
The pictures below show the depth of the rust layer and the condition of the substrate beneath. Also apparent, is the level of corrosion present between the flange faces.

4. **Encapsulation:** various forms of external barrier coating are available for passive protection of vulnerable substrates. However, one which offers an ability to stabilise the substrate through inhibition, as well as an external barrier protection would seem to offer the most chance of success.

Enviropeel does not require the level of preparation required for conventional coating systems. For standard Enviropeel applications, contact between the coating and the substrate provides a thin film of inhibiting oil that coats the substrate, preventing the corrosion process. Although the rust scale would be between the steel surface and the outer coating, the film will still perform this inhibiting function, but the inevitable increase in porosity of this substrate compared with normal steel, means that additional inhibitor would be required to ensure complete isolation. This is standard practice for Enviropeel applications where clean steel substrates cannot be obtained.

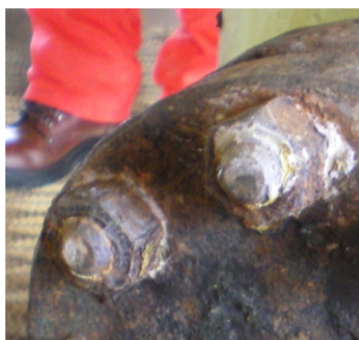
Below: a fully cleaned substrate shows that the bolts and nuts appear to retain reasonable integrity.

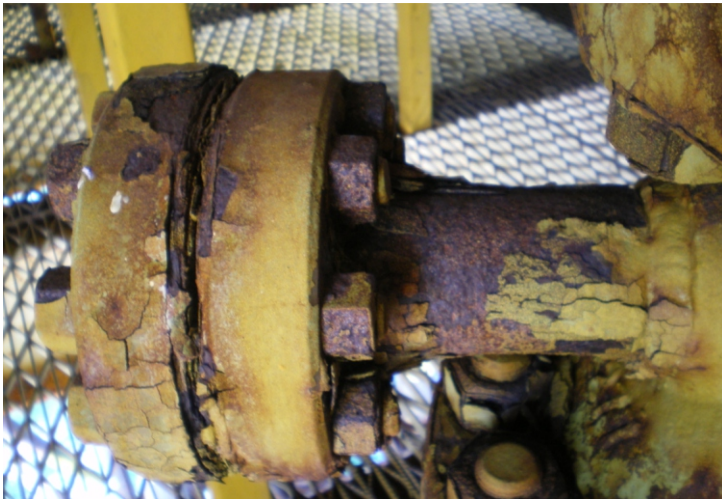
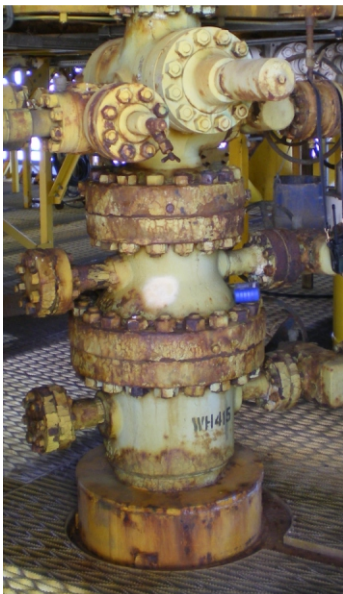
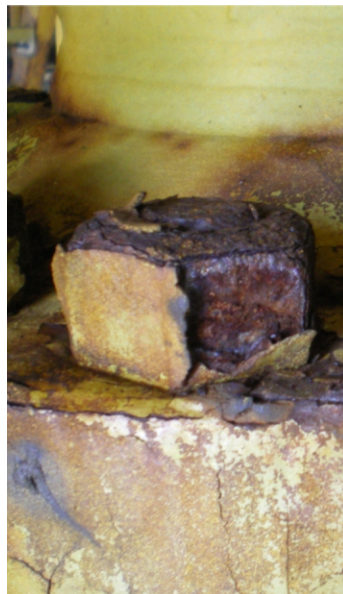
The Leman Delta platform operated by Shell was showing signs of its age. The photos below show a typical well head on the structure, with heavy corrosion and closer details of corrosion effects on flanges and bolts.

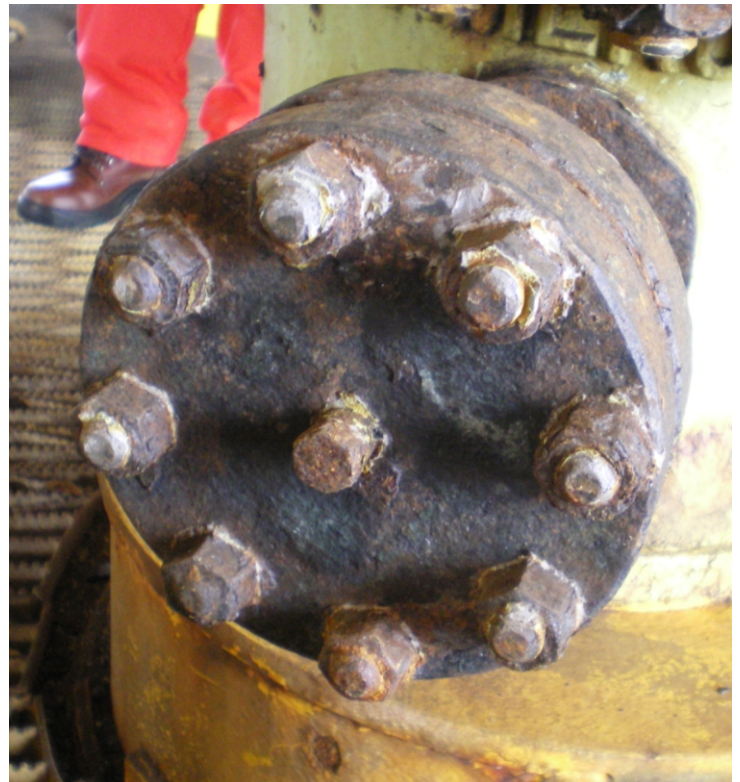
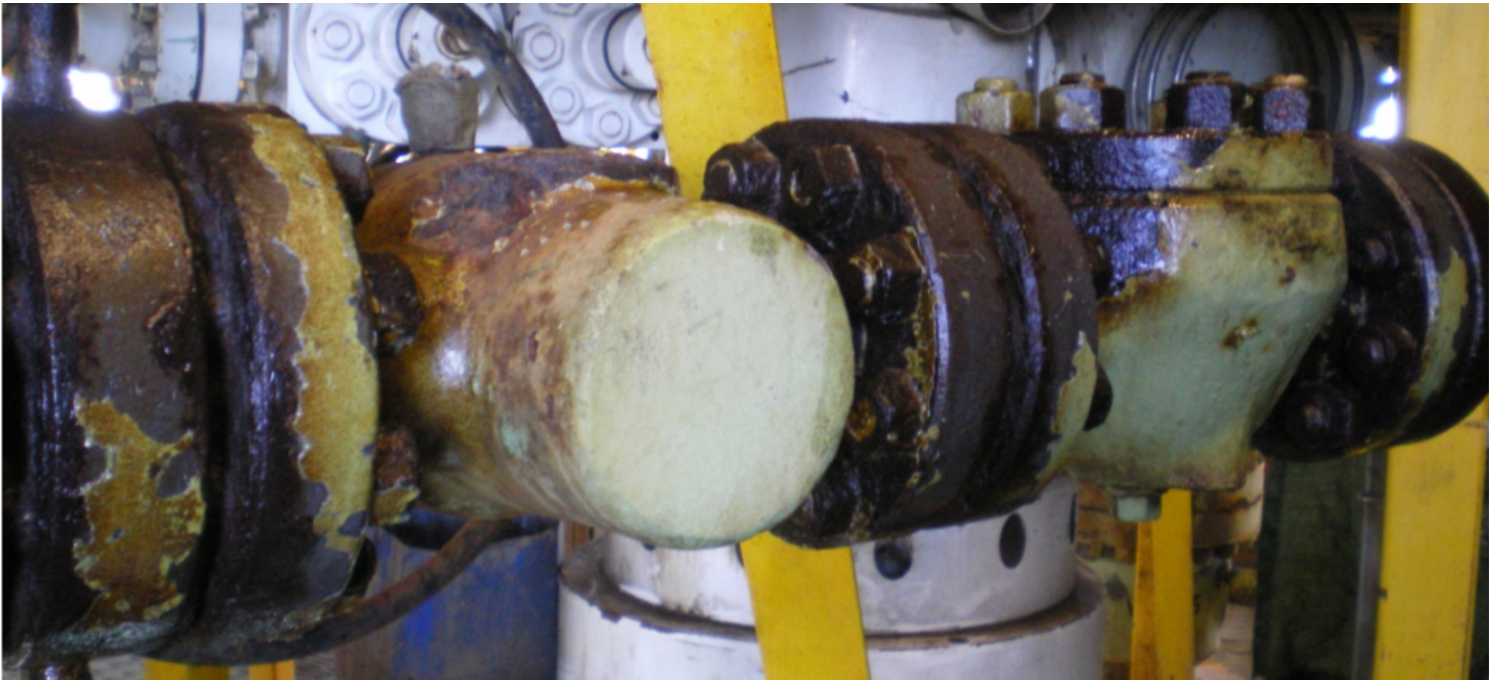
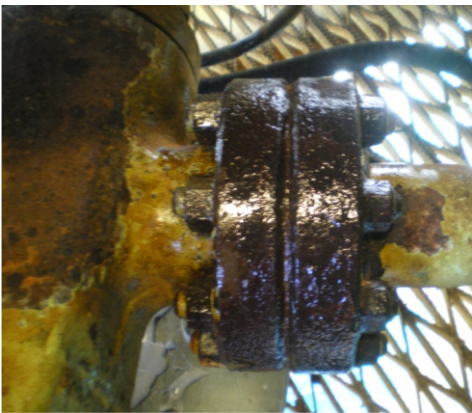
Removal of corrosion showed the condition of substrate. The depth of corrosion is clearly visible as corrosion scale is removed. It was not possible to completely remove corrosion between flange faces.

The bottom photo shows preparation complete on a typical small flange, ready for application of inhibitor.

The pictures above and left show elements of a well head following removal of all unsound material and the application of Enviropeel pre-treatment inhibitor to condition the substrate and ensure full inhibitor penetration.

Once the preparation of the substrate was complete, Enviropeel was applied to the flanges and joints. This application is designed to arrest all existing corrosion within the encapsulation and prevent any further deterioration of the substrate, fully protecting the infrastructure for a minimum of ten years.
