## AGGREGATE PRODUCTION

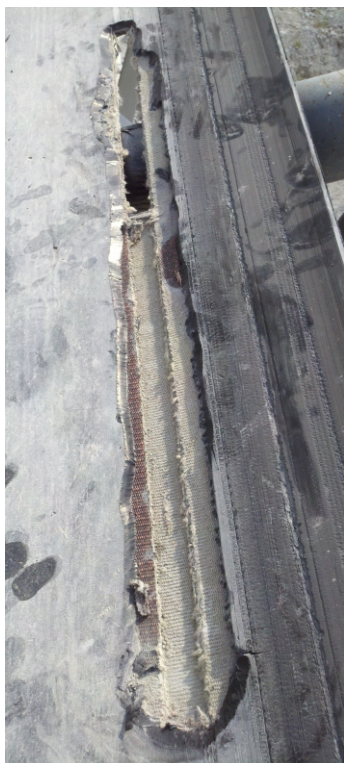
A large aggregate producer in Indiana had a long through hole in an incline belt. The belt transported material from the primary crusher in which large chunks of limestone were broken into more manageable pieces. The damage was producing a lot of spillage and the tear was getting bigger every day. Rubberloc was used to repair the damage in just a few hours and the belt was immediately returned to full service. The repair was still intact when the belt was replaced during routine maintenance nearly four years later. Typically, a Rubberloc repair will outlast the service life of the belts on which it is used, with tests showing that Rubberloc's adhesion to the repaired surface is stronger than the belt itself!

The photo above shows the severe damage to the belt. On the right, the same area of the belt is shown, following repair with Rubberloc

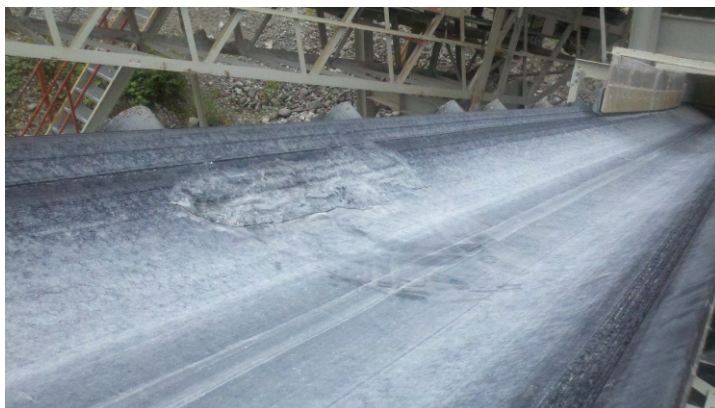
The photo above was taken eighteen months after the repair was completed - showing the durability and integrity of the repair.
