RUBBERLOC

Conveyor belt repair system

AGGREGATE PRODUCTION

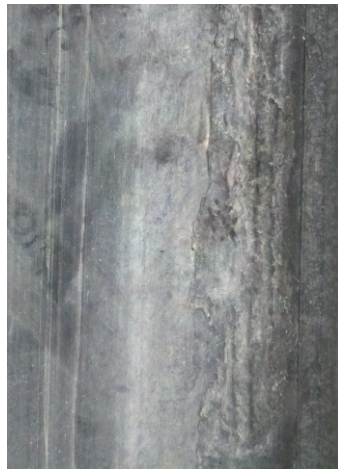
A large aggregate producer in Indiana had a long through hole in an incline belt. The belt transported material from the primary crusher in which large chunks of limestone were broken into more manageable pieces. The damage was producing a lot of spillage and the tear was getting bigger every day. Rubberloc was used to repair the damage in just a few hours and the belt was returned to service. The repair was still intact when the belt was replaced during routine maintenance nearly four years later.

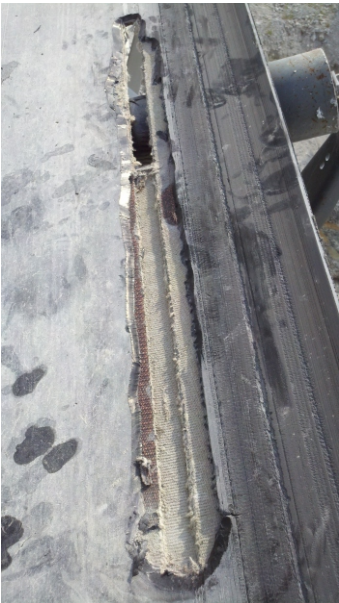
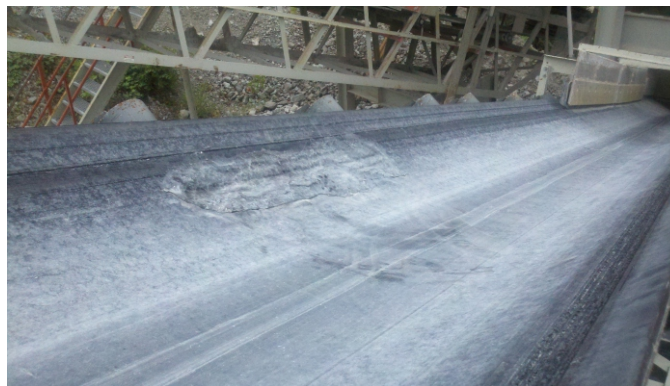
The photos of the repaired belt, shown left, were taken eighteen months after the repair was completed.
