SHELL LEMAN DELTA REPORT DOCUMENTS

Leman Delta - Enviropeel Inspection Visit – 10.08.16

SHELL LEMAN DELTA FOLLOW UP REPORT

SHELL LEMAN DELTA

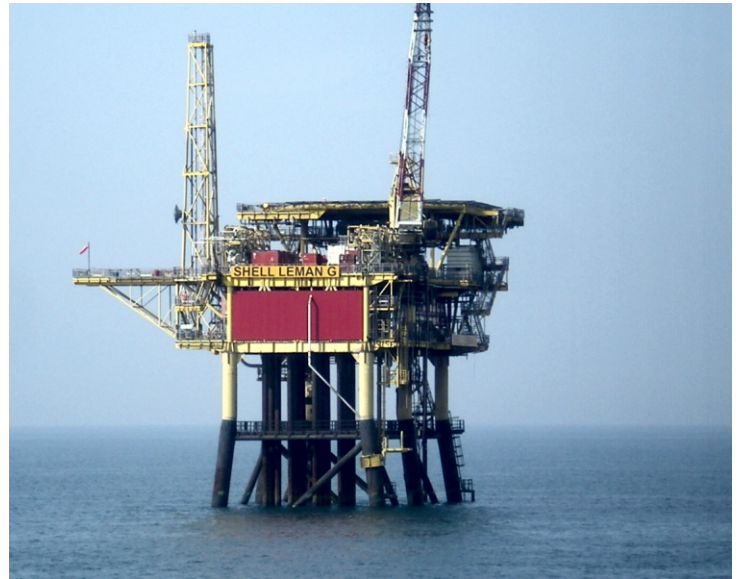
This platform is located in the UK sector of the North Sea, an area where around 70 offshore platforms have been in operation for more than 30 years and another 55 for 20-30 years, some well beyond their original design lifetimes. Effective maintenance of offshore platforms and their equipment is paramount for safety and continuity of production - but costs and challenges to success are high.

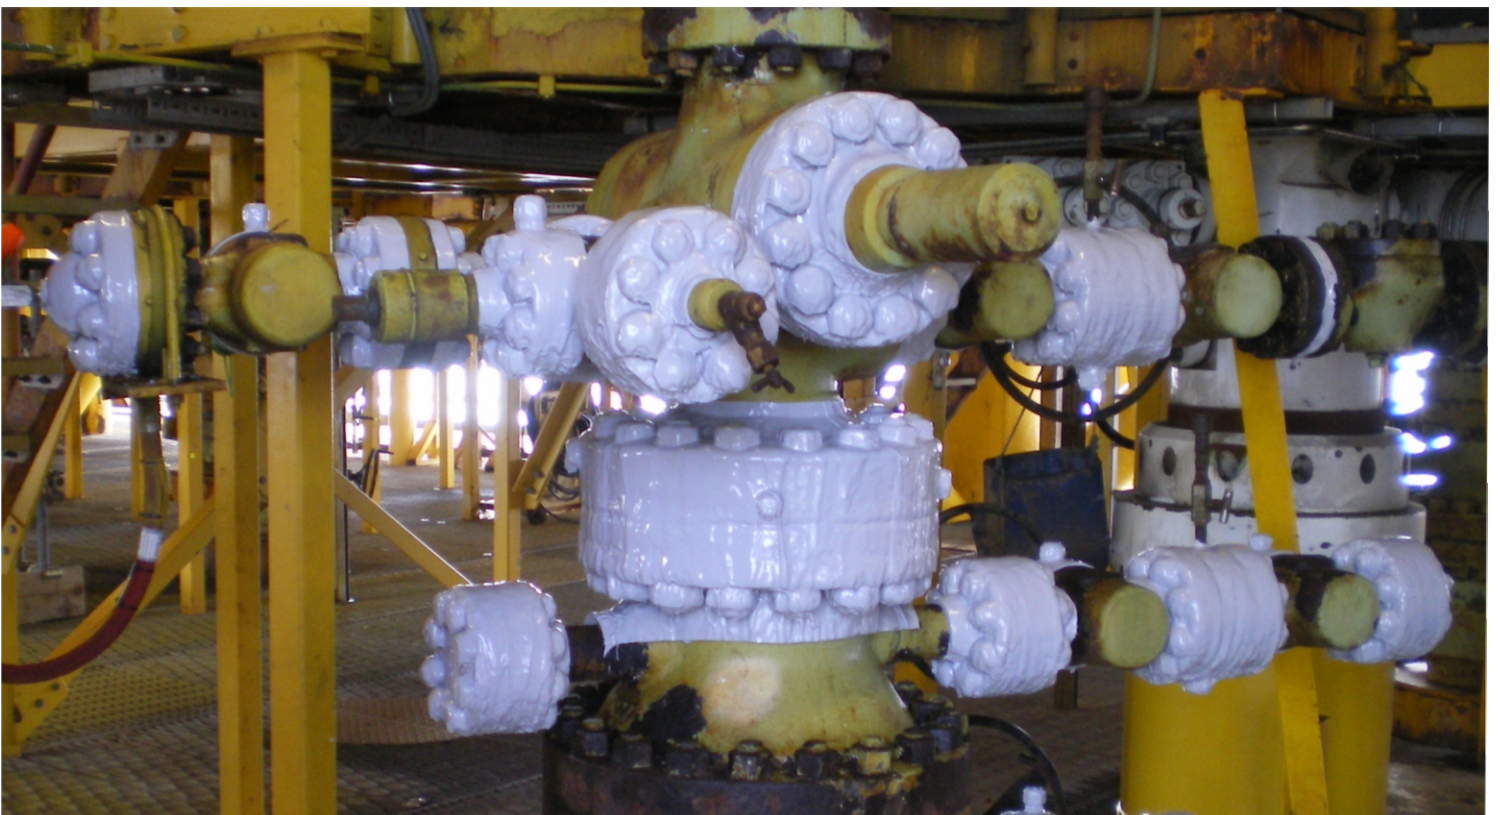
Once the preparation of the substrate was complete, Enviropeel was applied to the flanges and joints. This application is designed to arrest all existing corrosion within the encapsulation and prevent any further deterioration of the substrate, fully protecting the infrastructure for a minimum of ten years.
